# Manhole Inspection Summary

## Manhole # S29AA1008MH

Insp Date: **12/11/06 3:25 PM**

**Location** Address: **725 36TH ST**

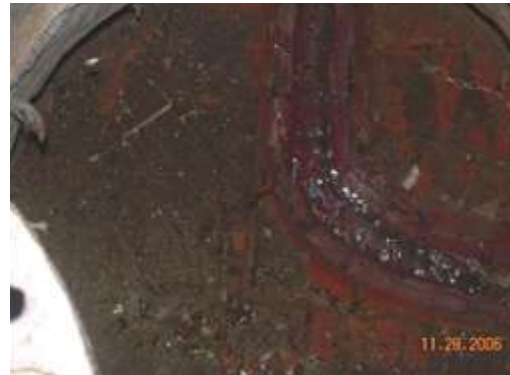
Top View

Corroded and missing steps. Evidence of surcharge - Bench debris.

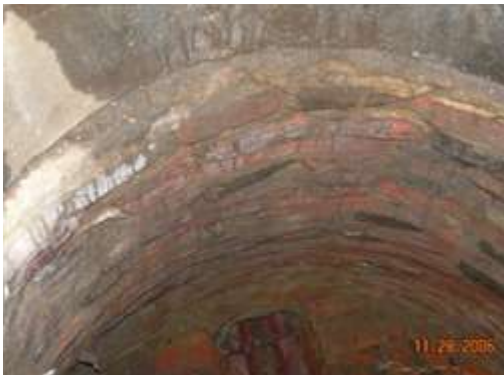
Defect

Frame leaks. Adjustment deterioration and infiltration. Corbel and Barrel infiltration.

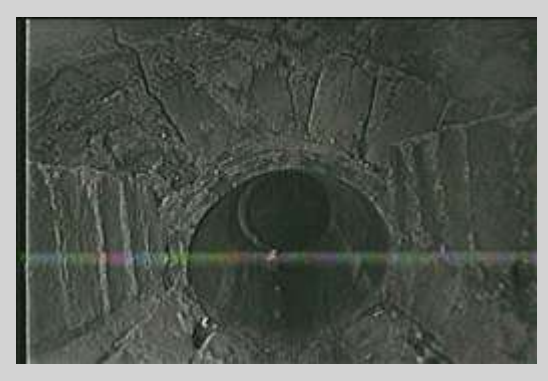
Pipe Out @ 12 O'Clock

Barrel cracks and infiltration. Channel deterioration.

Infiltration: **Evidence** Pipe Seal Cond: **Cracked**

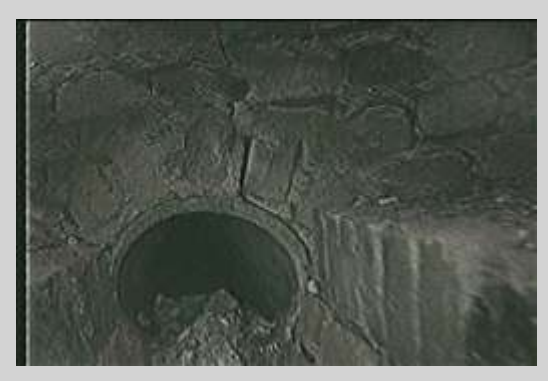
Pipe In @ 3 O'Clock

Barrel deterioration and infiltration. Channel deterioration.

Infiltration: **Evidence** Pipe Seal Cond: **Cracked**
